Journal of Current Research in Oral Surgery 2022, Volume 2, Page No: 6-15 Copyright CC BY-NC-SA 4.0 Available online at: <u>www.tsdp.net</u>

A Retrospective Evaluation of Anatomical Structure Perforations Associated with Dental Implants Using Cone Beam Computed Tomography

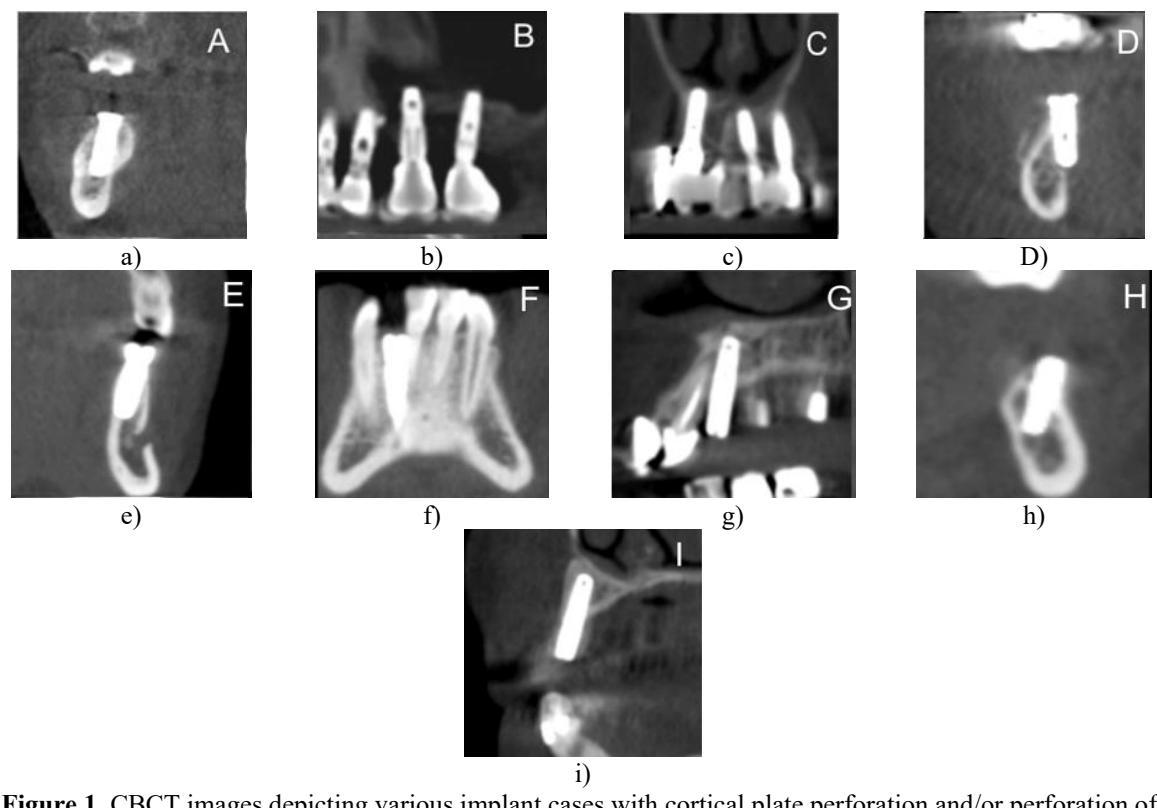
Figure 1. CBCT images depicting various implant cases with cortical plate perforation and/or perforation of other anatomical structures include (a) inferior alveolar nerve canal, (b) maxillary sinus, (c) nasal fossa, (d, e) cortical plate, (f, g) adjacent tooth root, (h) inferior alveolar nerve canal with cortical plate perforation and thread exposure, and (i) buccal and palatal cortical plate perforation along with thread exposure.

Cases of implants exhibiting cortical plate perforation and/or perforation of various anatomical structures are illustrated in (**Figure 1**). A presurgical cone-beam computed tomography incorporating a radiographic stent was performed for only 119 implants (27%). Among the total implants, 193 implants (43.76%) were positioned appropriately without any perforation of the cortical plate or adjacent anatomical structures. In contrast, 27 implants (6.12%) exhibited both cortical plate perforation and perforation of a neighboring anatomical structure (**Table 1**). Perforation of adjacent anatomical structures was observed more frequently in the posterior region compared to the anterior (P = 0.03); however, no statistically significant difference was found when comparing occurrences between the maxilla and mandible. A comprehensive breakdown of perforation occurrences based on anatomical location is presented in **Table 2**.
